Charles White

Refuse Chutes

Chute Riser Testing & Results

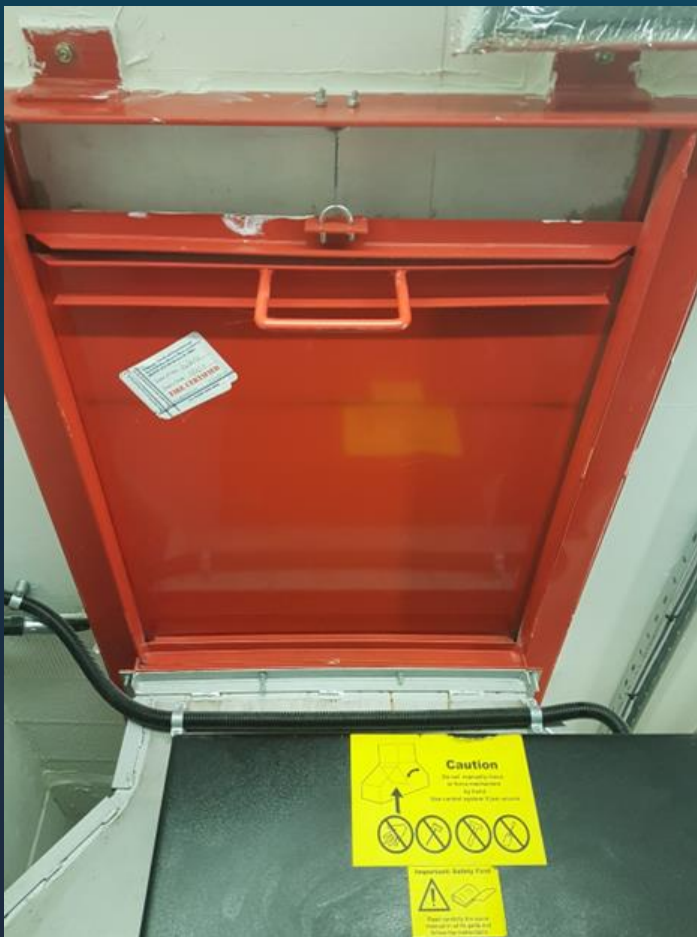
Chute Fire Closure Plate (Shutter)

Spring Loaded

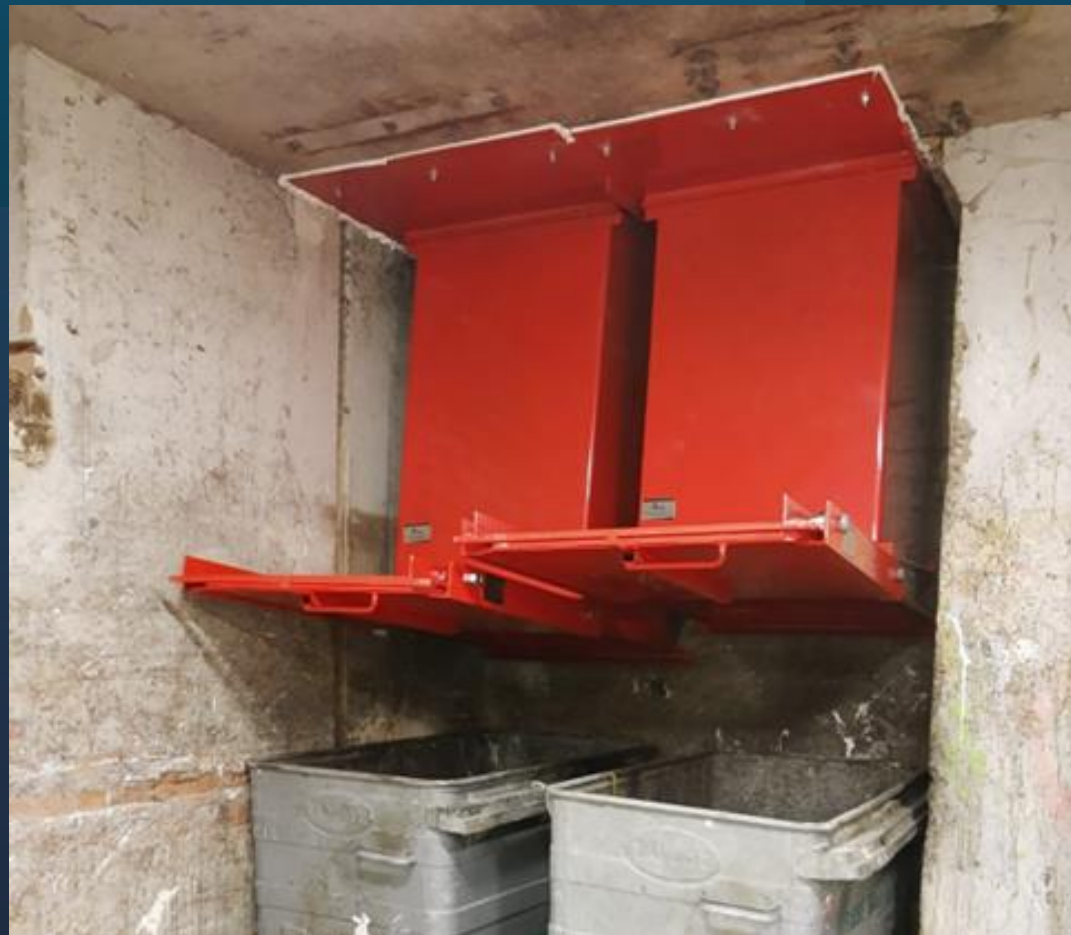
Gravity Movement

Fusible Links

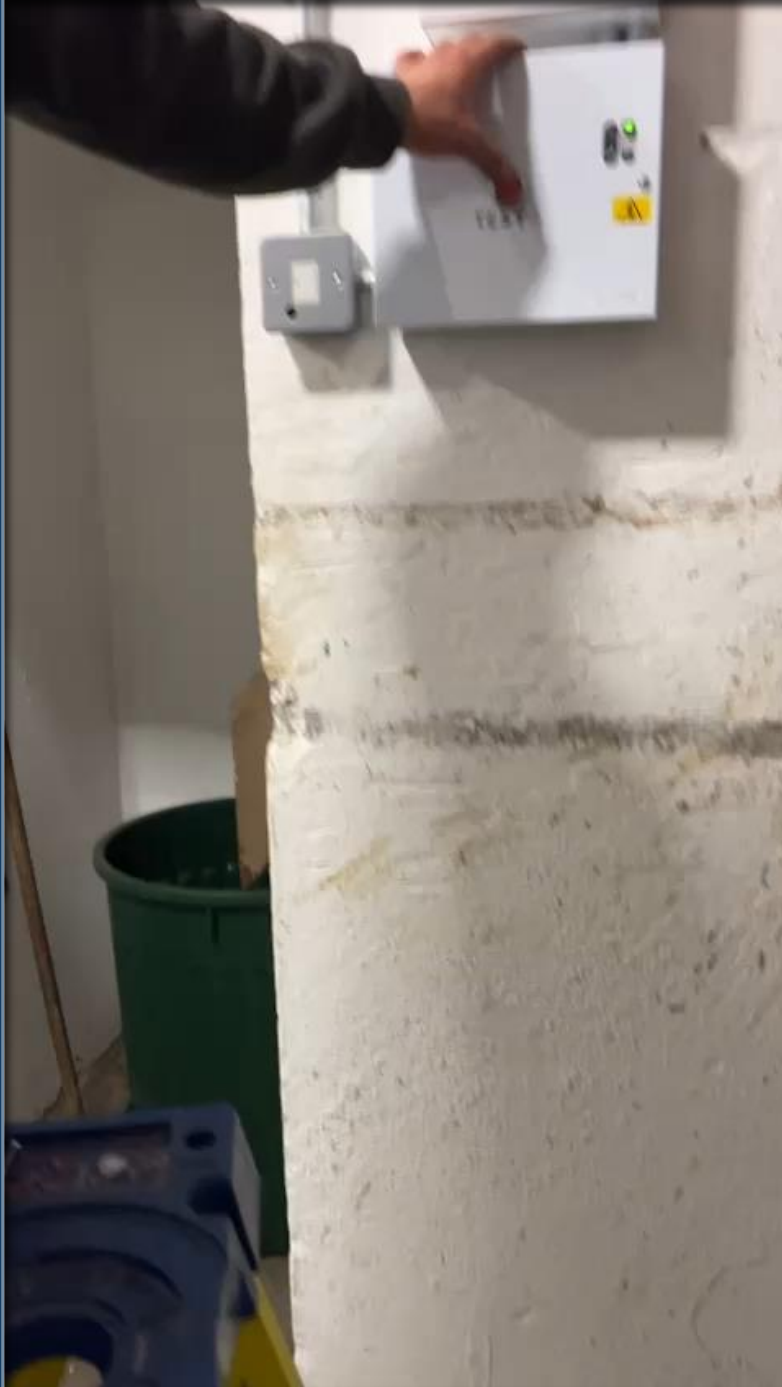
Smoke Sensor

Mag Lock FCP's

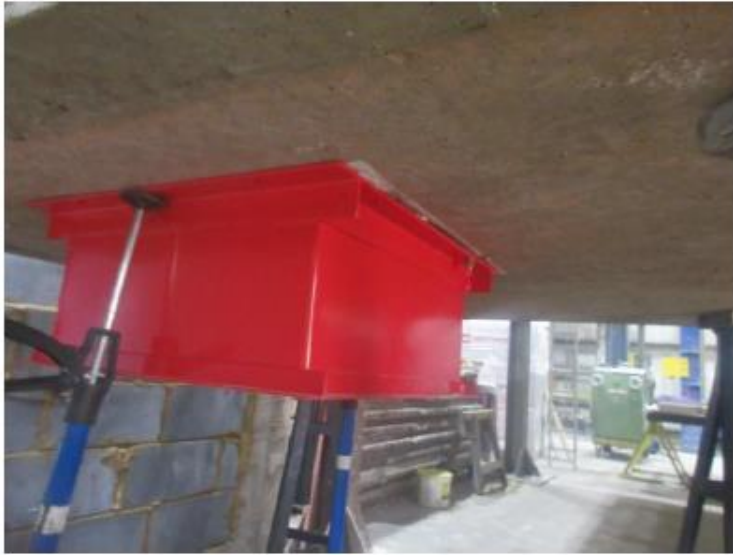
Photo 3. Installation of chute to underside of concrete slab.

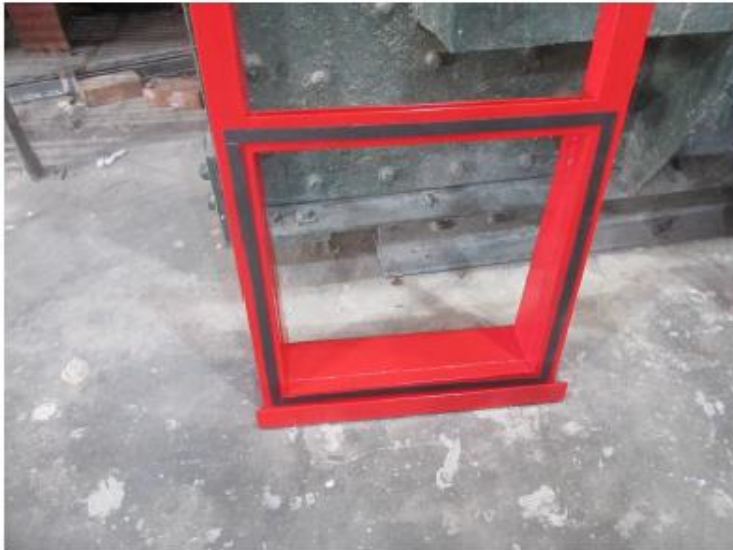
Photo 4. Thermaflex Intumescent strip applied to the underside of Main frame.

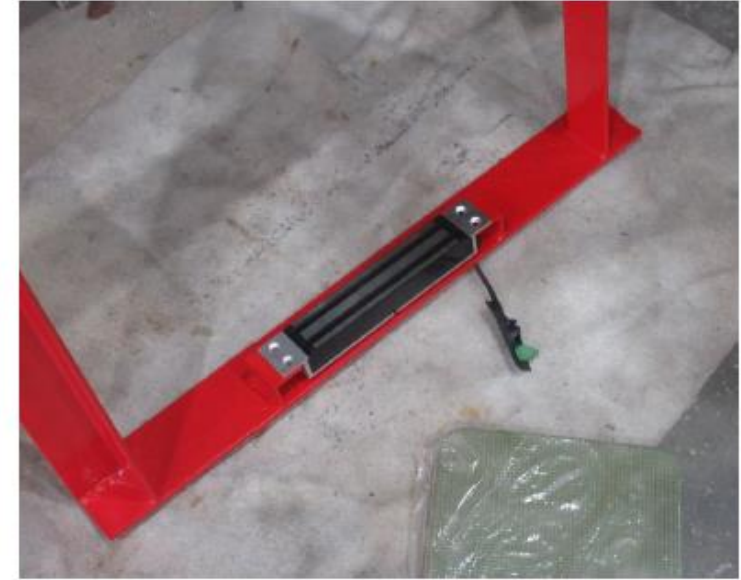
Photo 5. Installation of mag lock 600M onto Main frame.

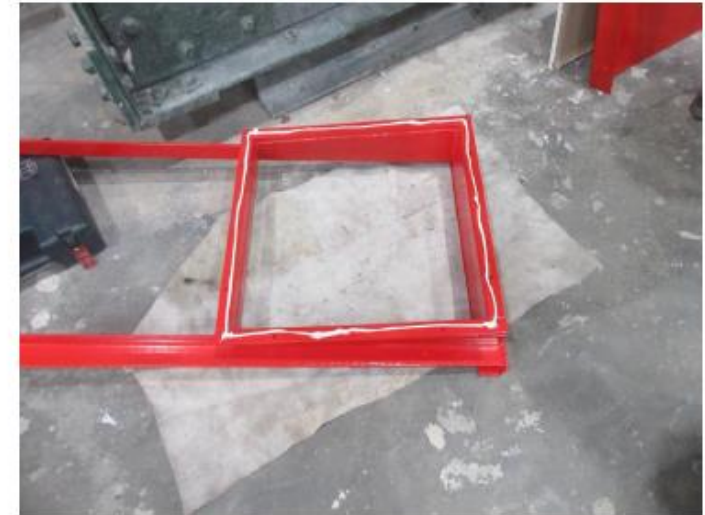
Photo 6. Application of Everflex Firemate Intumescent sealant on to the Main frame steel angle flange.

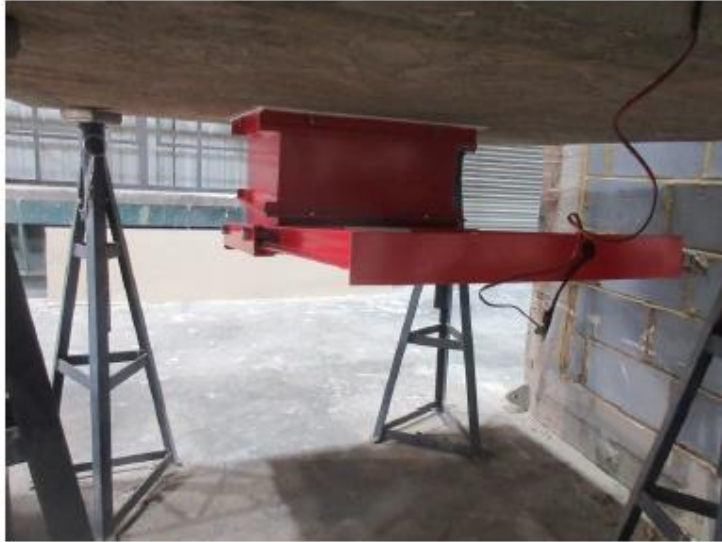
Photo 7. Completed installation.

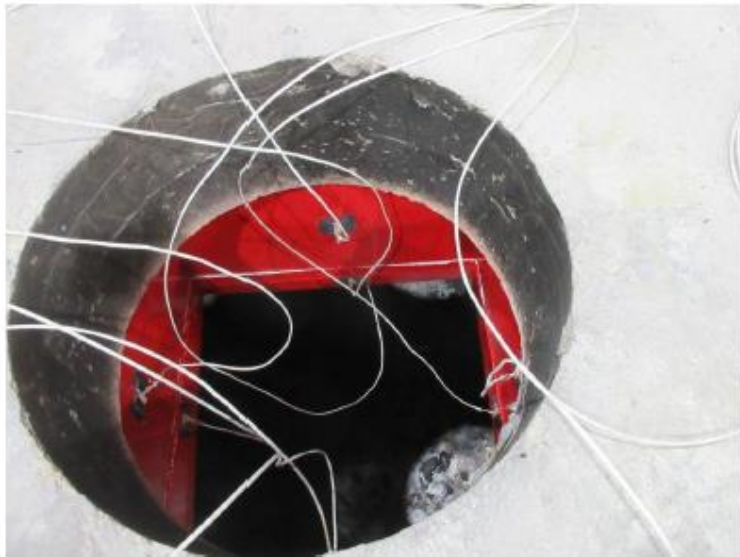
Photo 8. Chute viewed from Non-fireside (with installation of thermocouple for information only).

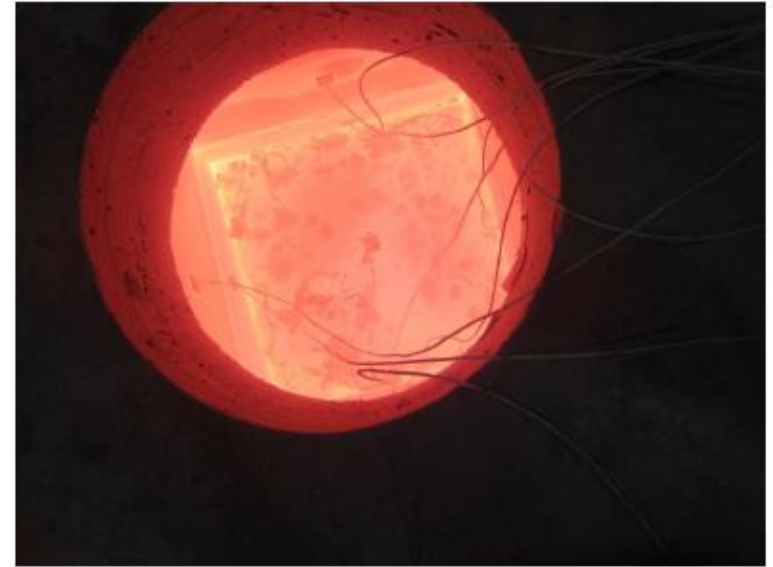
Photo 13. After completion of 180mins.

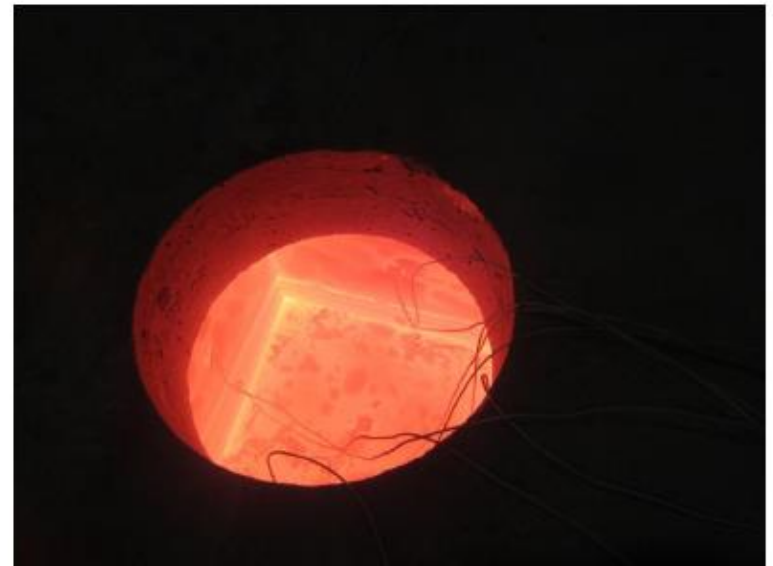
Photo 14. After completion of 240mins.

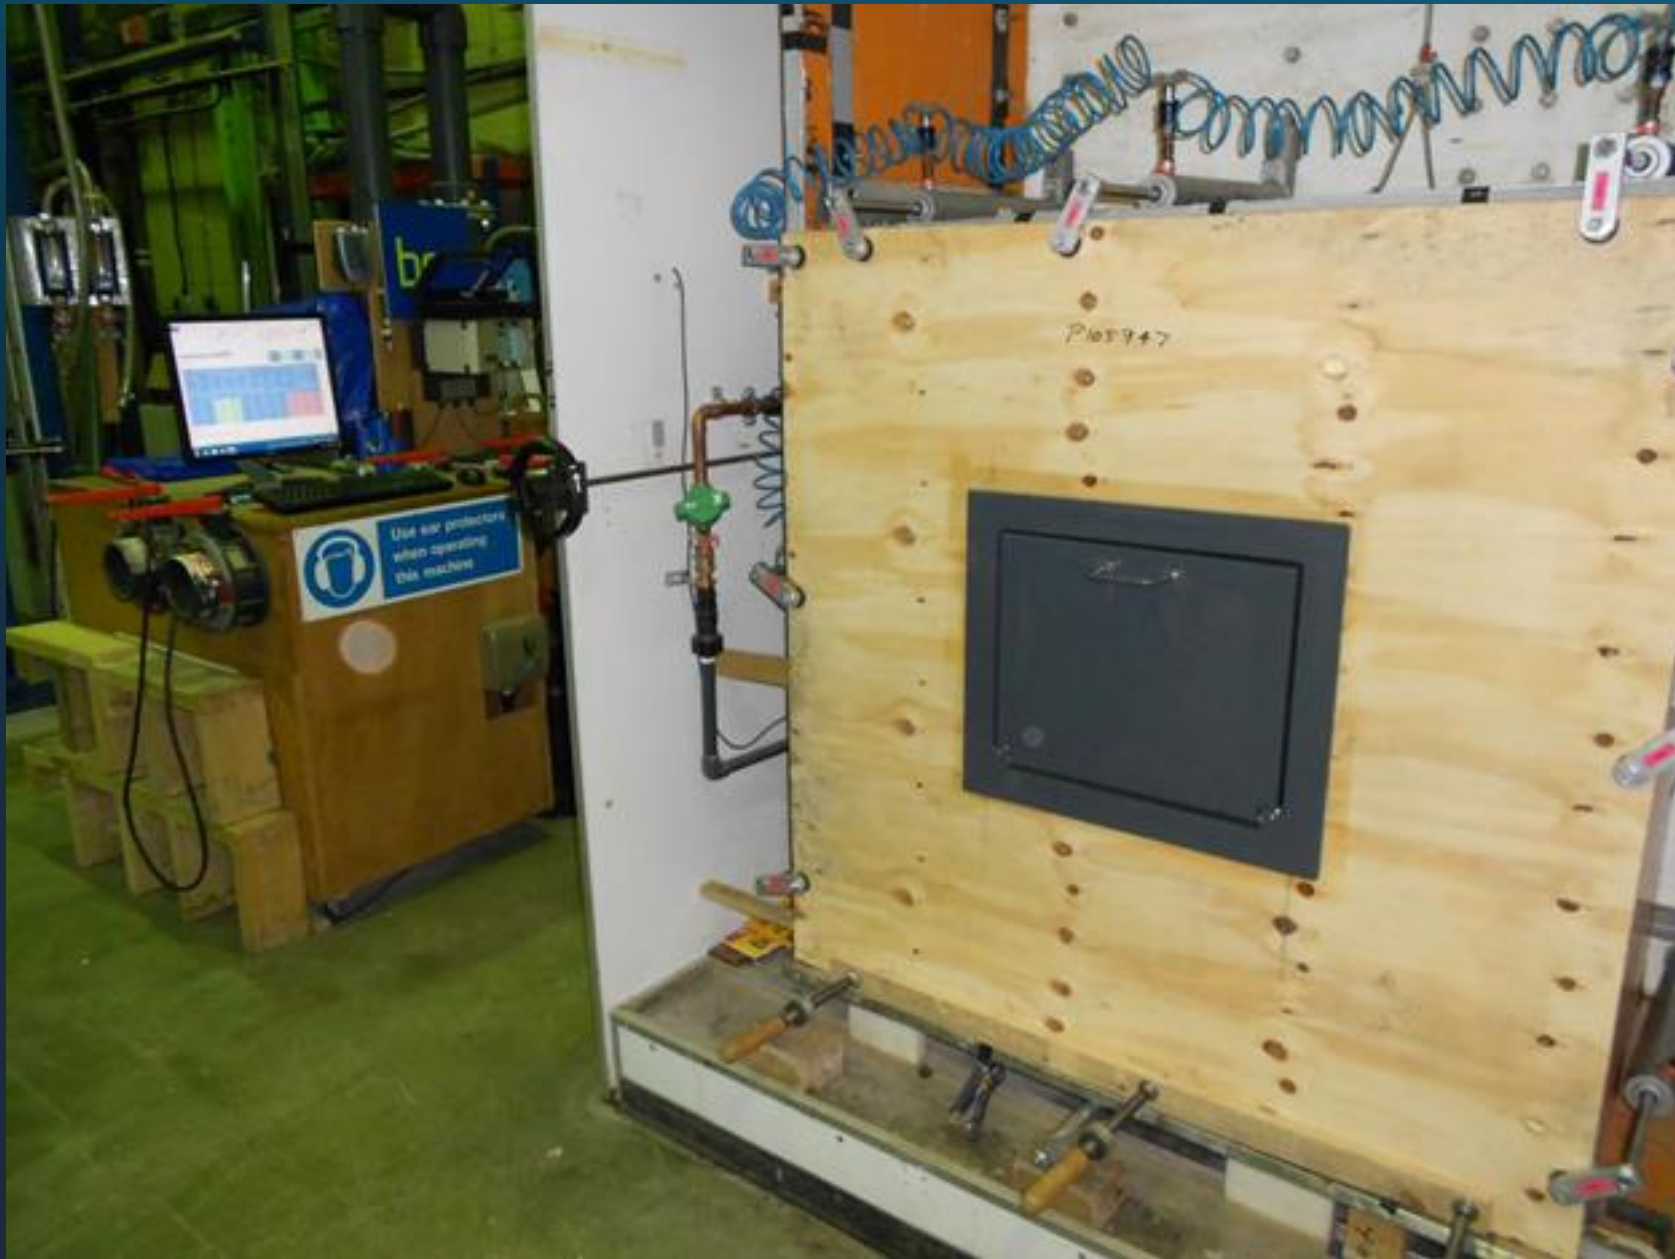
BS EN13051-2:2007 + A1:2009.

Hopper Seal Locations

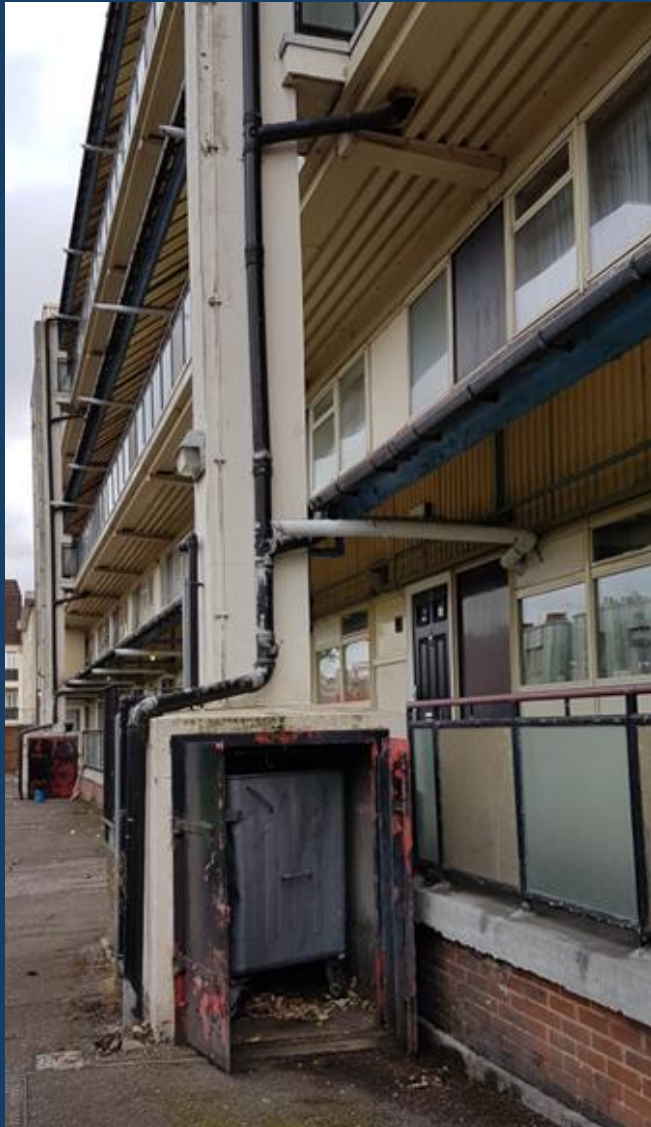
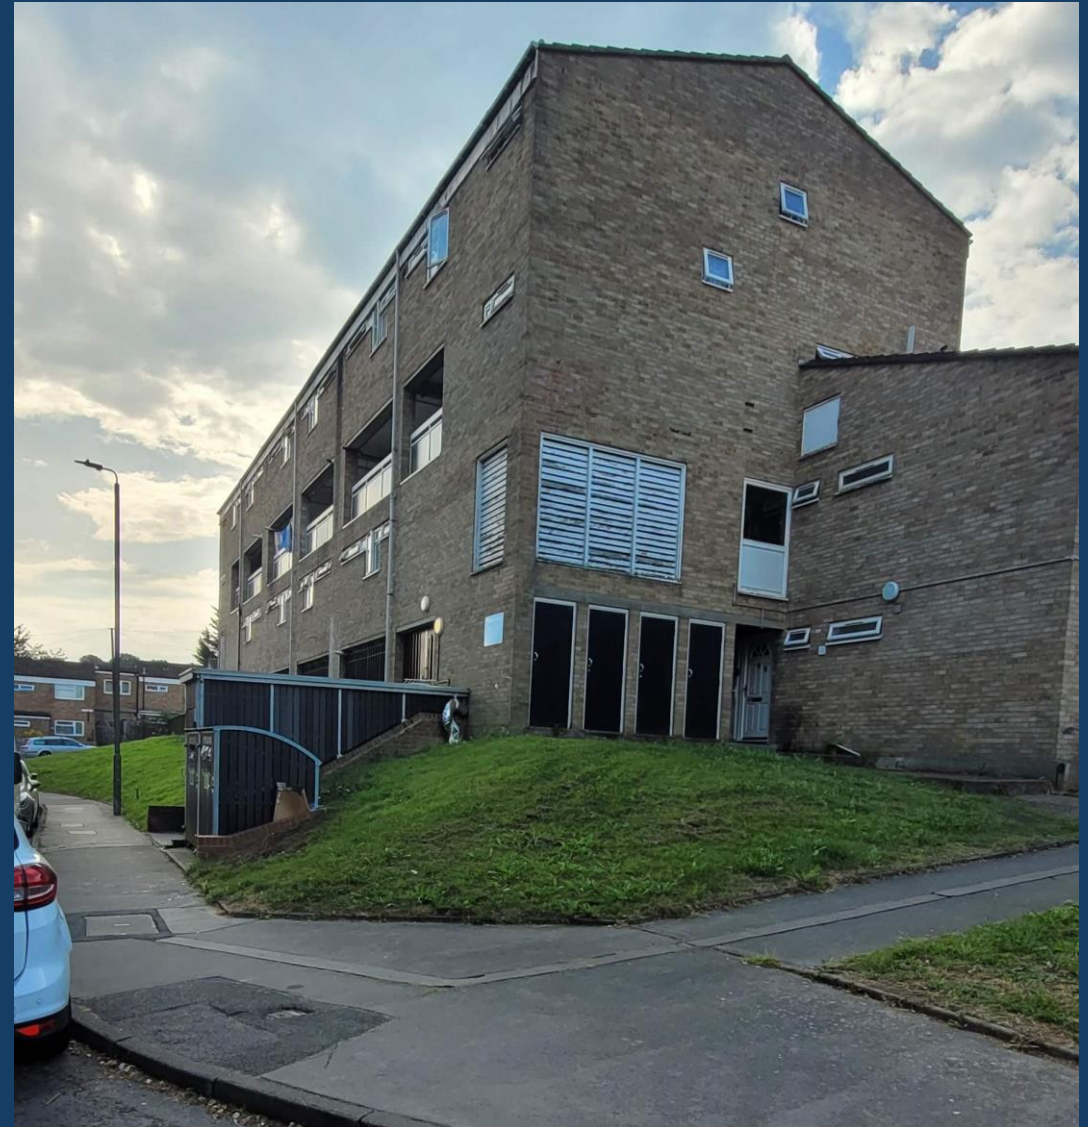
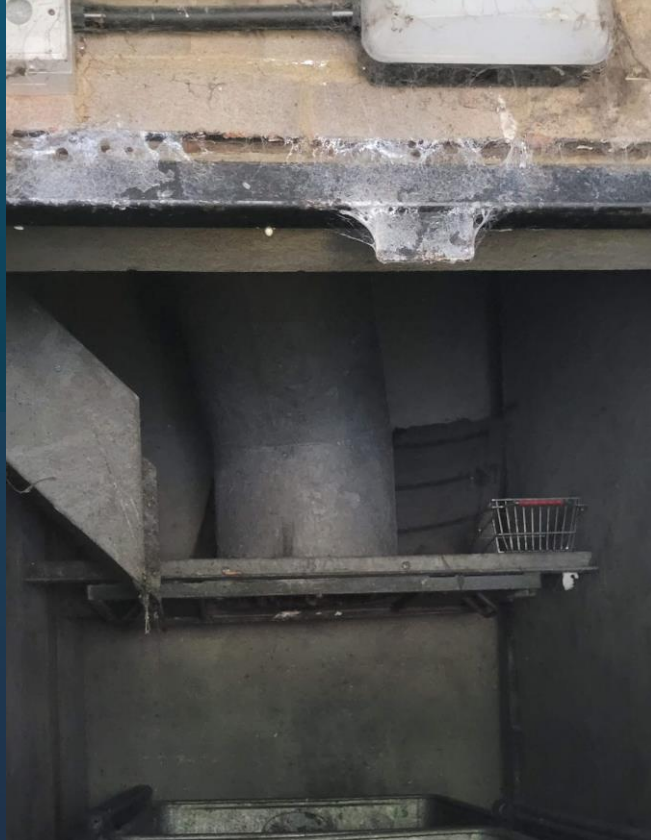
Do both buildings require a fire closure plate..... or neither?

Is the chute an integral part of the building?

Yes = FCP needed

No = No FCP needed

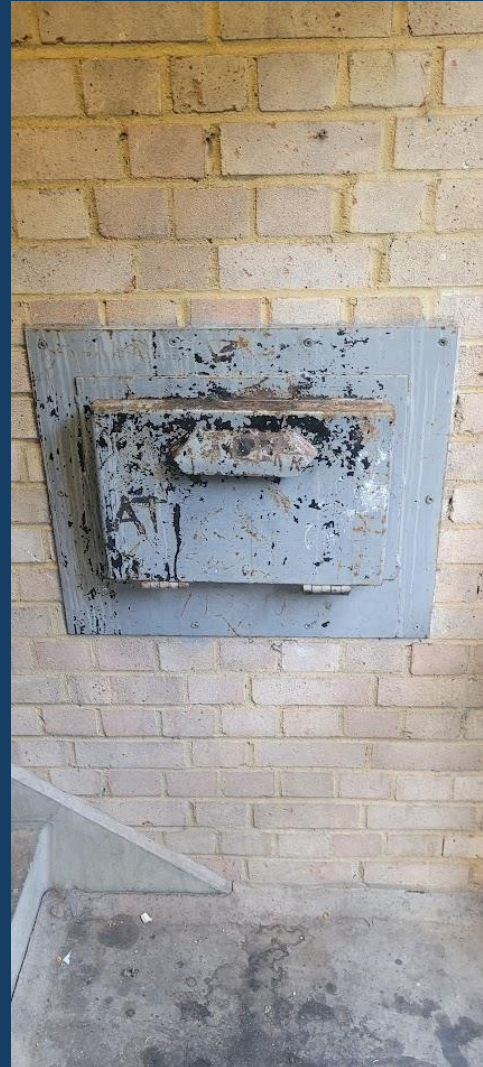
Should this hopper be tested for smoke tightness?

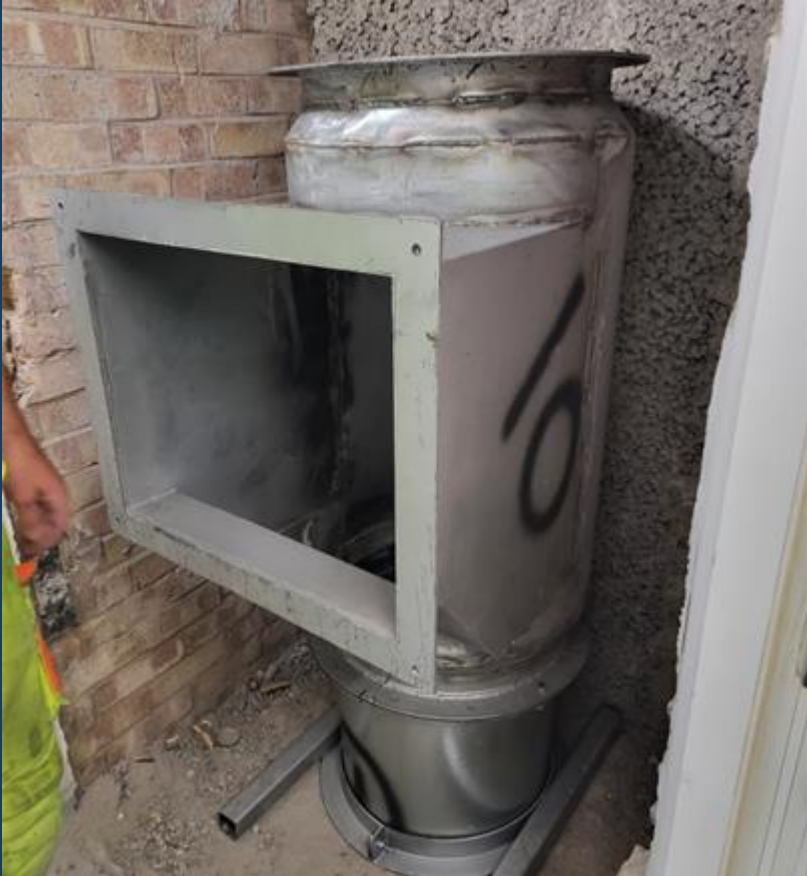
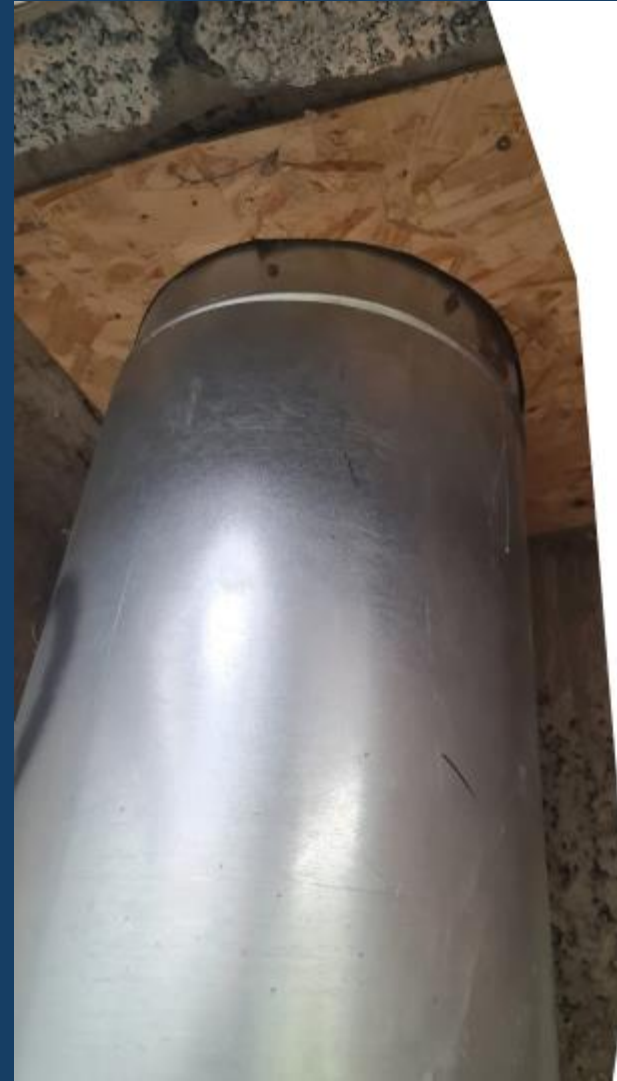
Final Checks

Fire stopping from above with sand/cement or
C20 concrete or intumescent cement

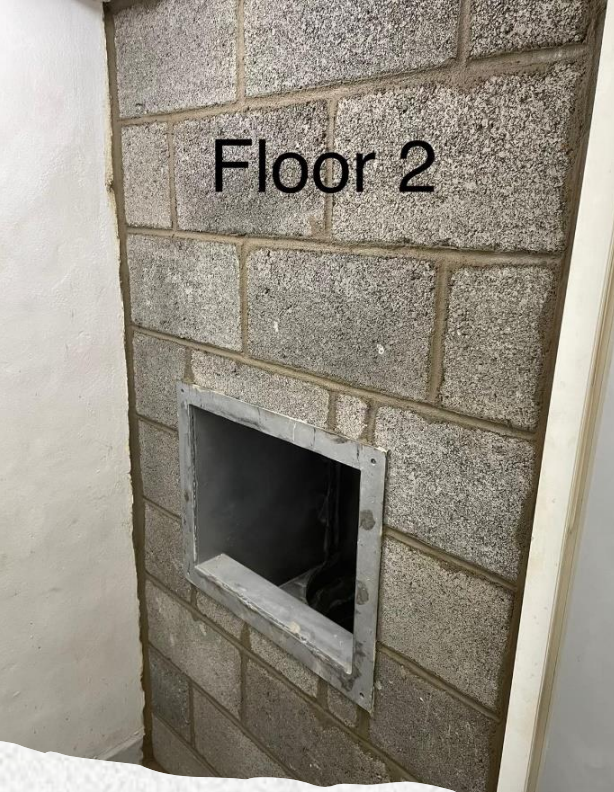
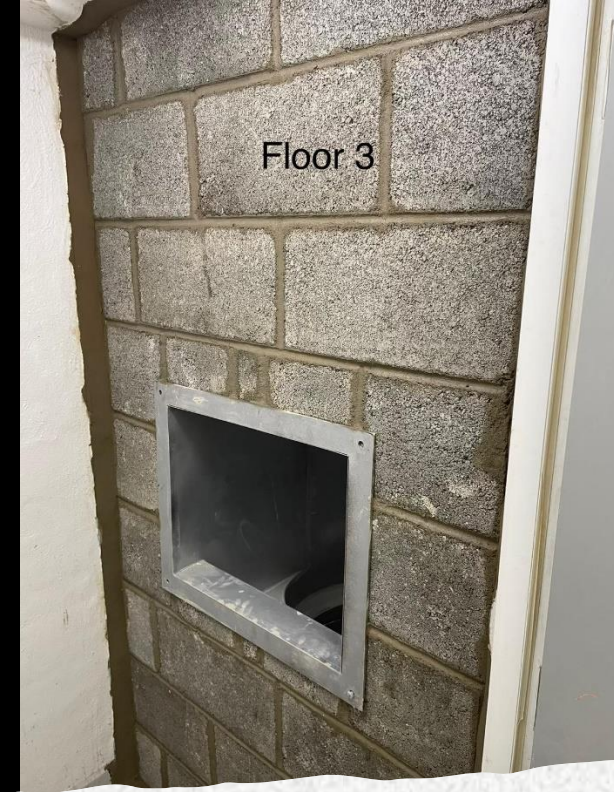
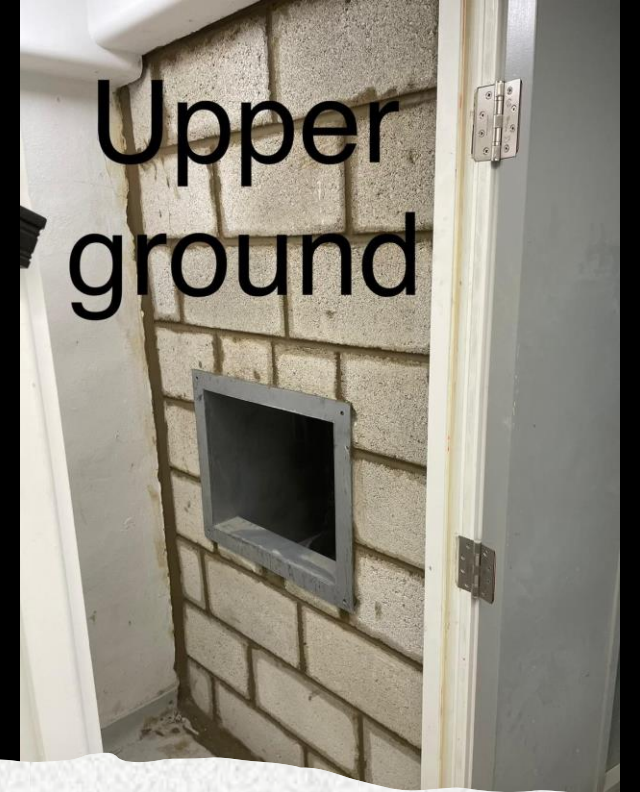
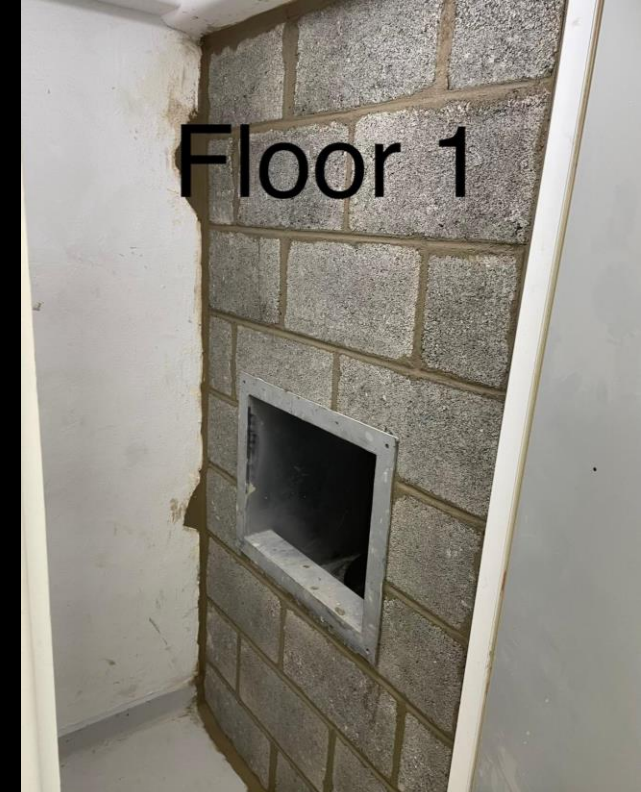
New Riser Walls

New **240 Minute**
Fire Rated **AND** Smoke Tight Rated Hoppers
